Manhole Inspection Summary

Manhole # S33CC_044MH

Insp Date: **7/18/08 11:44 AM**

Location Address: **924 CHARLES ST**

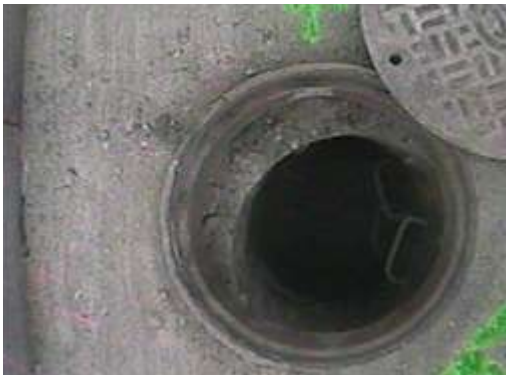
Defect 2

Frame Offset: **4** (in.) Condition: ☒ Sound ☐ Cracked ☐ Leaks

FRAME OFFSET

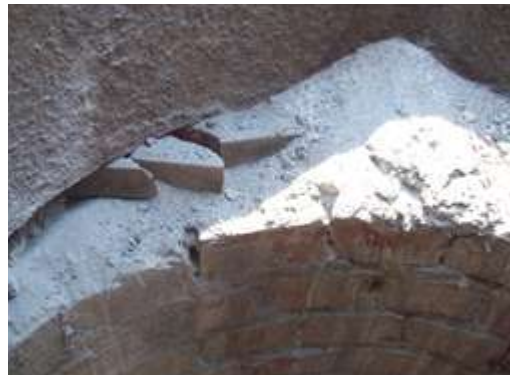
Defect 1

Condition: ☐ Sound ☒ **Cracked** ☐ Root Intrusion ☒ **Loose Brick** ☐ Deteriorated

CRACKED AND LOOSE BRICKS ON CHIMNEY

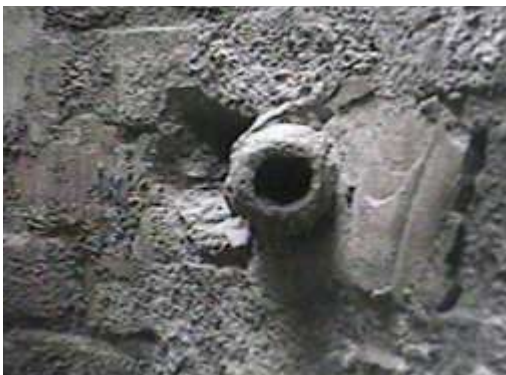
POSSIBLE ILLCIT CONNECTION

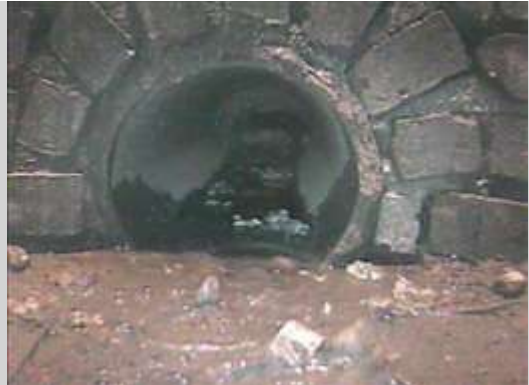
12 O'Clock Outflow

8 in. Circular Gravity Sewer
Pipe Out @ 12 O'Clock

Pipe Height: (in.) Direct
Pipe Material: **Clay** ☐ Pipe Lined
Invert Depth: **12.08** (ft.) Flow Characteristics: **None**
Deposits: ☐ None ☐ **Mud** ☒ **Sludge** ☒ **Debris** ☐ Grease
Silt Depth: **0** (in.) Deposits Extent: **Light**
Infiltration: **None** Pipe Seal Cond: **Sound**

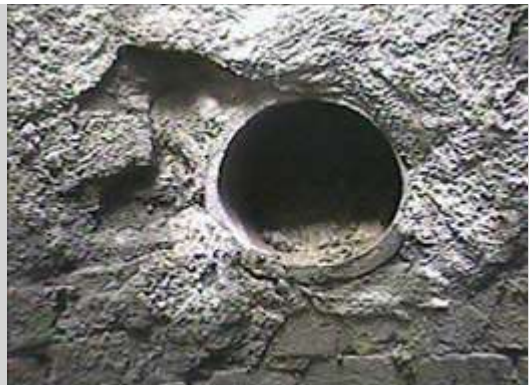
6 O'Clock Inflow

6 in. Circular Gravity Sewer
Pipe In @ 6 O'Clock

CRACKED AND LOOSE BRICKS ON
CHIMNEY

Pipe Height: (in.) Direct
Pipe Material: **Clay** ☐ Pipe Lined
Invert Depth: **4.25** (ft.) Flow Characteristics: **None**
Deposits: ☐ None ☒ **Mud** ☒ **Sludge** ☒ **Debris** ☐ Grease
Silt Depth: **0** (in.) Deposits Extent: **Light**
Infiltration: **None** Pipe Seal Cond: **Sound**
